CRHOA Board Meeting Agenda

November 6, 2019 (Revised 11/03/19 - Added pgs 36 & 37)

7:15 CRYSTAL RIDGE DRIVE ENTRANCE MONUMENT REPLACEMENT and EASEMENT

7:25 RESERVE REPORT & 2020 BUDGET DISCUSSION and VOTE

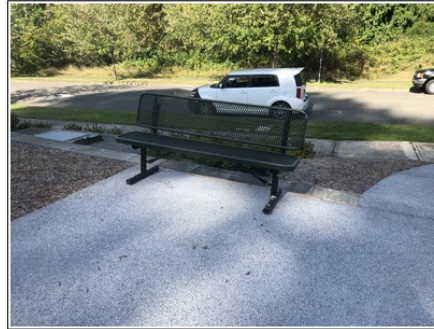
Site/Grounds - Bench: Replace

Quantity: 1 Each
 UL: 30
 RUL: 29
 Current Cost: \$1,100
 Condition: Fair
 Funding Basis: Funded based on the typical life expectancy

Good condition with no unusual deterioration or instability observed. No history of concern. Repair as needed from the operating budget. Best to plan for total replacement for appearance and functionality.

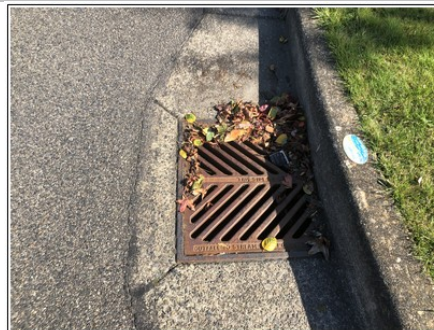
Site/Grounds - Drainage

Current Cost:
 Condition: Unknown
 Funding Basis: Unfunded, not Association responsibility

Public utility responsibility.

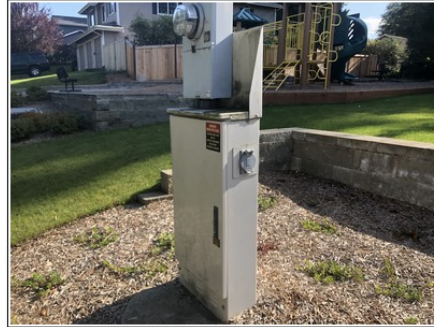
Mechanical & Equipment - Electrical

Current Cost:
 Condition: Unknown
 Funding Basis: Unfunded outside the 30 year scope of report

No reported problems. Analysis of the electrical system is beyond the scope of a reserve study. At this time, there is no expectation of significant repair or expenses required. Minor amount of electrical equipment that can be funded from the Operating budget.

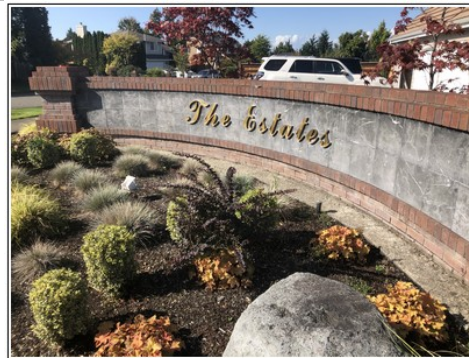
Site/Grounds - Entry Monument: Clean & Repair, The Estates

Location: Entry
 Quantity: 4 Allowance
 UL: 25
 RUL: 0
 Current Cost: \$4,000
 Condition: Good
 Funding Basis: Funded based on the typical life expectancy

Good condition with no issues at this time. Sturdy construction and materials. No expectation of large scale expenses at this time. Funded for cleaning and minor repairs as needed.

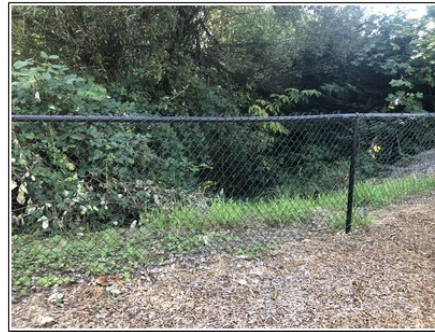
Site/Grounds - Fence: Chainlink, Replace

Quantity: 60 Linear Feet
 UL: 37
 RUL: 10
 Current Cost: \$1,680
 Condition: Fair
 Funding Basis: Funded based on the typical life expectancy

Fair condition of the black vinyl chain link fencing. The life expectancy of these units are approximately 30 years. Reserve funding recommended.

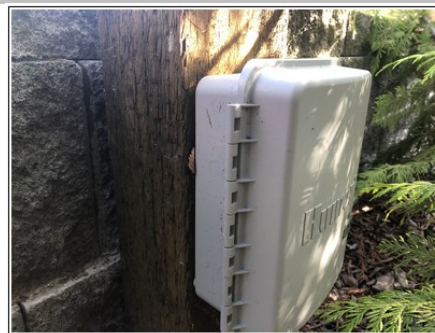
Site/Grounds - Irrigation System: Repair/Replace

Quantity: 1 Allowance
 UL: 1
 RUL: 0
 Current Cost: \$10,000
 Condition: Assorted Condition
 Funding Basis: Funded based on the typical life expectancy

Assorted condition with significant expenses every year. As the community and irrigation lines age, local areas of line replacement may be needed and generally is not covered by the landscape contract. At this time there is no expectation of total line replacement, however, we have included an allowance for partial repair/replacement annually. As these expenses occur and trends are developed update the reserve funding as needed.

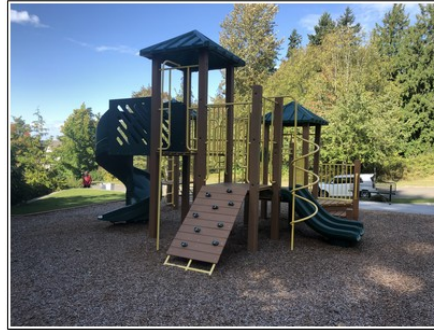
Recreation - Recreation Equipment: Replace

Condition: Excellent

Excellent condition with no structural instability or unusual deterioration noted during our inspection. Inspect regularly and refurbish fall zones and repair as needed utilizing the operating budget. Reserve funding recommended.

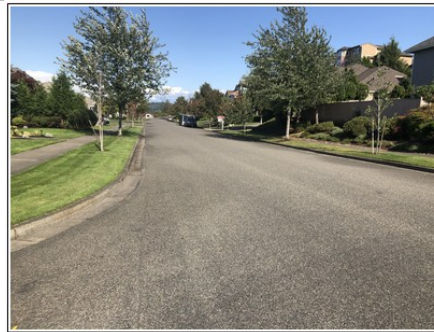
Site/Grounds - Streets

Condition: Assorted Condition

Dedicated to the Public.
